TFL 48 – Canfor and BC Timber Sales – 2014 CSA Z809 Re-certification Audit Public Summary Report

Between February 15th and March 5th, 2014 KPMG Performance Registrar Inc. (KPMG PRI) carried out a CSA Z809 re-certification audit of Canadian Forest Products Ltd. (Canfor)'s and B.C. Timber Sales (BCTS)' operations within the Tree Farm Licence 48 Defined Forest Area (DFA). This certification summary report, which covers both the Canfor and BCTS certifications, provides an overview of the audit process and KPMG's findings.

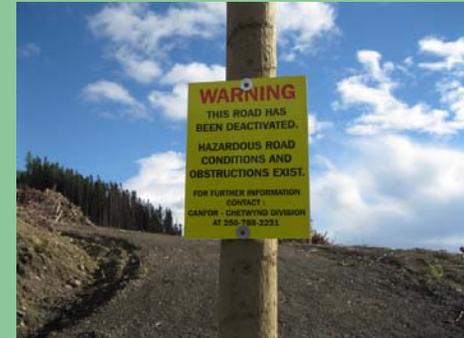
After harvesting and silviculture operations are complete on-block roads are deactivated (removal of bridges and culverts, installation of cross-ditches, revegetation of ditchlines) to help minimize risks to riparian values. In order to help ensure public safety, signs are installed on deactivated roads to notify potential users.
